MANDATORY**MEL-24-04****TITLE**

ELECTRICAL POWER - TRANSMITTAL OF CONTINENTAL AEROSPACE TECHNOLOGIES CRITICAL SERVICE BULLETIN CSB19-06

ALERT SERVICE BULLETIN No. 081 Rev. A

Alternator Castellated Hex-Nut Inspection

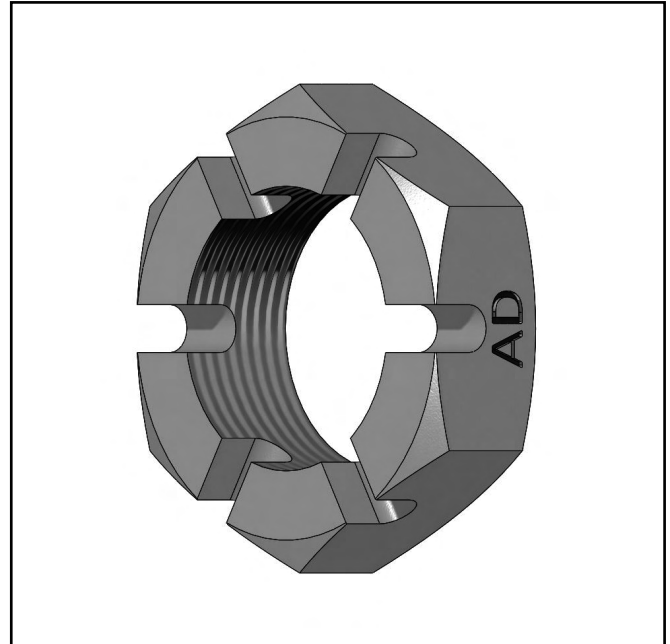
Figure 4 - Roll-Stamped "AD"

- B. Revise 3.B.2.(c) to reflect change to Figure 4:
 - (1) Change to: Hex-nut (1) is roll-stamped with the letters "**AD**".
 - C. Add task 3.B.(6) for clarification:

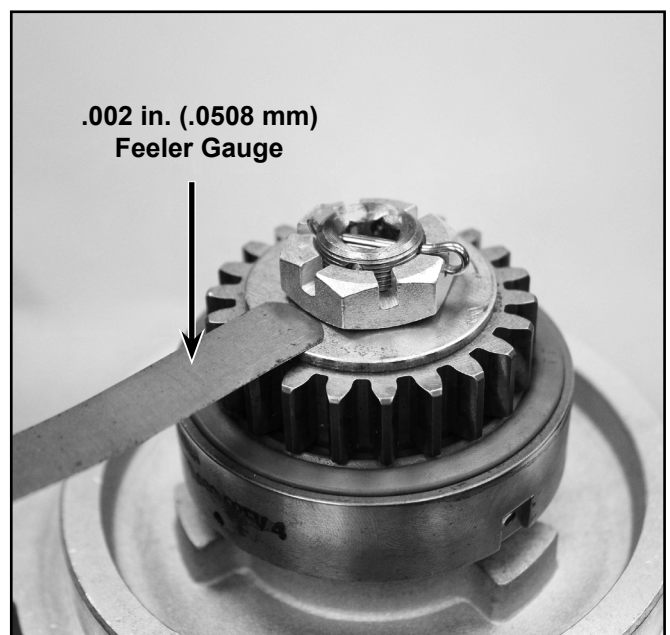
Figure 6 - Gap Measurement

- (1) Remove the alternator from the engine in accordance with the latest revision of the aircraft and/or engine manufacturer's maintenance manual.
- (2) Inspect castellated hex-nut (1). If one the following indicators is present, the alternator is in compliance with this ASB. Refer to Figures 3 thru 5.
 - (a) Hex-nut (1) is laser etched with the letter "H";
 - (b) Hex-nut (1) is stamped with a center-punch;
 - (c) Hex-nut (1) is roll-stamped with the letters "AD".
- (3) If any indicator stated above **is not** present, proceed to 3.B.(4). If one of the indicators stated above **is** present, continue to 3.B.(8).
- (4) Using a .002 in. (.0508 mm) feeler-gauge, measure the gap between the nut thrust face and the thrust washer at each of the six hex-nut flats. Refer to Figure 6.

- (a) If the measurement at any nut flat is \geq .002 in. (.0508 mm), continue to 3.B.(5).
- (b) If the measurement at each nut flat is $<$.002 in. (.0508 mm), no corrective action is required.
 - 1) Using an automatic center punch, punch the face of the hex-nut (1) so that it will be easily identified for future reference (Refer to Figure 5). Continue to 3.B.(8).
