SERVICE LETTER

MEL-71-05

POWER PLANT - TRANSMITTAL OF CONTINENTAL AEROSPACE TECHNOLOGIES SIL21-04B

SUBJECT: PURPOSE:	Improved Rocker Cover Gasket, Part No. 668893PENDING APPROVALAnnounce new part number availability and important installation instructionsPENDING APPROVAL	
COMPLIANCE:	CE: When replacing rocker cover gaskets	
MODELS AFFECTED:	Continental Aerospace Technologies new and rebuilt GTSI0520C, D, H, K, L, M, N; I0550D, E, F & L engines converted to crossflow cylinders; I0550G, N, P, R; I0F550G, N, P, R; TSI0520BE; TSI0550A, B, C, E, G, J, K, N; TSI0F550D, J, K & P engines.

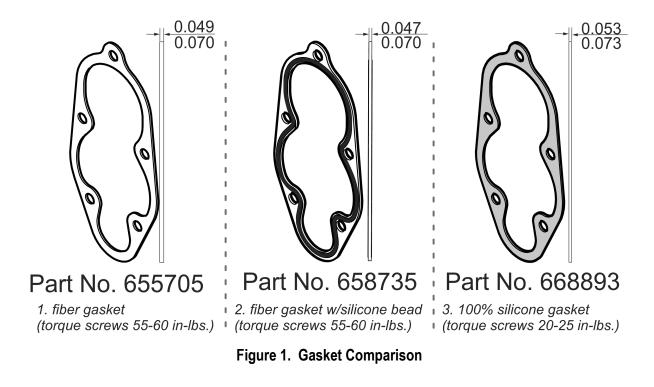
Rocker Cover Gasket Part No. 668893 is a flexible, silicone gasket, smooth on both sides; no special mating instructions apply. Rocker Cover Gasket Part No. 658735 is a fiber gasket with a silicone bead on both sides of the gasket. Gasket Part No. 655705 (preceded Part No. 658735) and previous gaskets used with crossflow style cylinders were fiber gaskets with no bead. Earlier gaskets were subject to age control; Part No. 668893 is not.

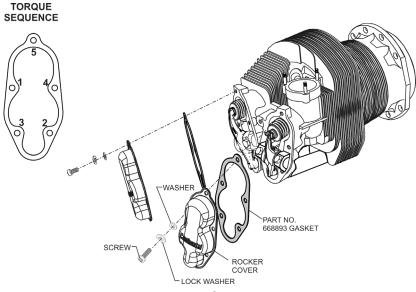
Figure 2. Rocker Cover Installation

CAUTION: Failure to clean the rocker and cover flanges will cause leaks. Surfaces must be clean and oil-free to seal properly. Applying 55-65 in-lbs. torque to rocker cover fasteners using Rocker Cover Gasket Part No. 668893 will damage the gasket and rocker cover.

- 1. Clean the rocker box (including threaded screw holes) and cover flanges thoroughly with isopropyl alcohol (IPA) or acetone before installing the gasket to remove oil and old gasket residue. Clean the rocker cover screw threads with a wire brush and rinse with IPA or acetone.
- 2. Install rocker cover(s) with new gasket according to instructions in the primary ICA.
- 3. Sparingly apply a thin bead of Continental Part No. 658517 (Loctite® 243) across the rocker cover screw threads according to the manufacturer's instructions. Secure each rocker cover with five screws and torque the screws in an alternating pattern (see Figure 2):

- a. On rockers using gasket Part No. 668893, torque cover screws 20-25 in-lbs.
- b. On rockers using any fiber gasket, torque cover screws 55-60 in-lbs.
