SEL-79-04

OIL - TRANSMITTAL OF CONTINENTAL AEROSPACE TECHNOLOGIES™ SB21-03 OIL TEMPERATURE CONTROL VALVE INSPECTION

CATEGORY 3 SB21-03

SUBJECT: Potential Failure of Oil Temperature Control

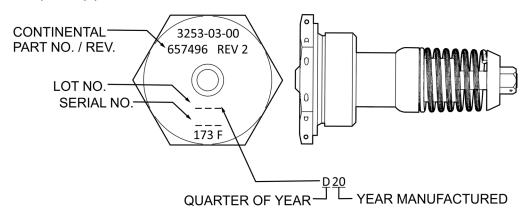
Figure 1. Oil Temperature Control Valve

The supplier of Continental Part No. 657496, Oil Temperature Control (Vernatherm) Valve Assembly, has identified a discrepancy in one lot of Part No. 657496. Affected units have a potential to leak internally and fail to actuate the piston assembly. Upon failing, these units will remain in the "cold" position, providing only limited oil flow through the engine oil cooler.

The lot number is etched on the cap of the assembly below the part number in the location shown in Figure 1. Remove and replace affected Part No. 657496, Vernatherm Assembly marked with lot number **D20** (2020O4) with a serviceable unit.

Remove and replace the Oil Temperature Control Valve (Vernatherm) on affected engines according to the engine instructions for continued airworthiness. If oil temperature exceeds 240°F for more than 30 seconds, perform an oil change according to instructions in M-0, Standard Practice Maintenance Manual.
