MANDATORY**MEL-24-04****TITLE**

ELECTRICAL POWER - TRANSMITTAL OF CONTINENTAL AEROSPACE TECHNOLOGIES CRITICAL SERVICE BULLETIN CSB19-06

ALERT SERVICE BULLETIN No. 081 Rev. A

Alternator Castellated Hex-Nut Inspection

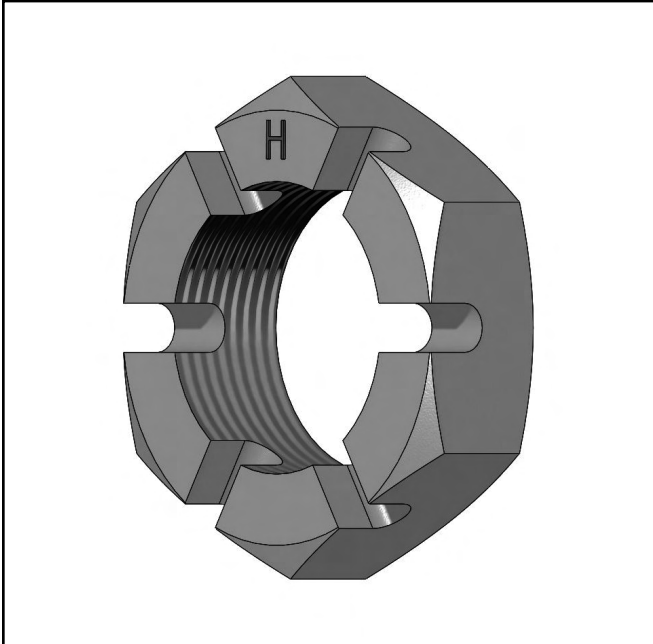
- (1) Remove the alternator from the engine in accordance with the latest revision of the aircraft and/or engine manufacturer's maintenance manual.
- (2) Inspect castellated hex-nut (1). If one the following indicators is present, the alternator is in compliance with this ASB. Refer to Figures 3 thru 5.
 - (a) Hex-nut (1) is laser etched with the letter "H";
 - (b) Hex-nut (1) is stamped with a center-punch;
 - (c) Hex-nut (1) is roll-stamped with the letters "AD".
- (3) If any indicator stated above **is not** present, proceed to 3.B.(4). If one of the indicators stated above **is** present, continue to 3.B.(8).
- (4) Using a .002 in. (.0508 mm) feeler-gauge, measure the gap between the nut thrust face and the thrust washer at each of the six hex-nut flats. Refer to Figure 6.

Figure 3 - Laser Etched "H"
